STRUCTURAL AUDIT REPORT

KALA ACADEMY, GOA

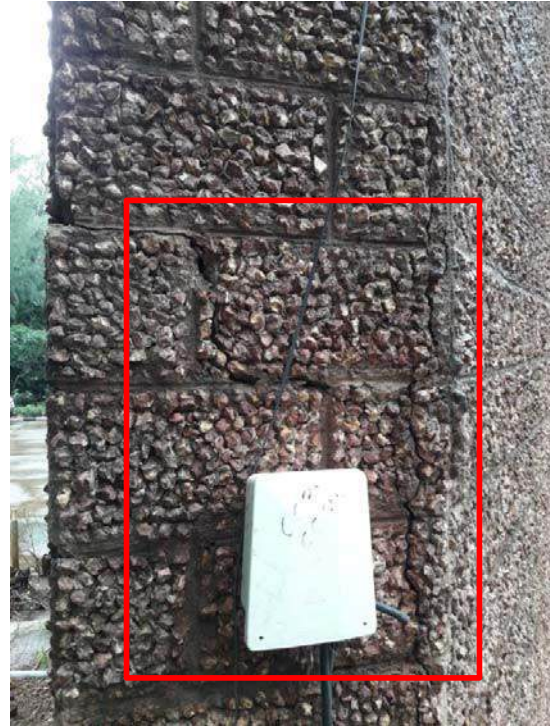
5. Recommendations of NDT:

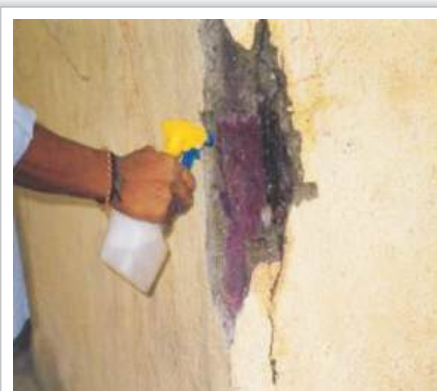
- Carbonation test gives the depth in mm to which the carbonation has taken place in the concrete cover.

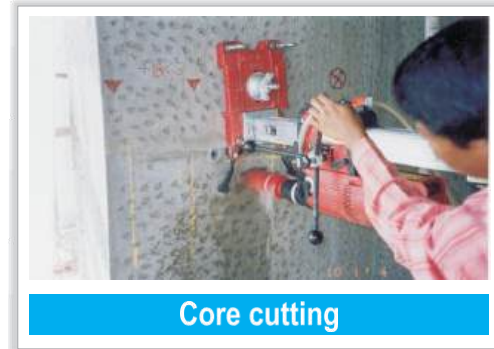
- The result is normalized for comparison with compressive test results of a standard cube. This is done so that the cube results can be compared with the core results. Standard correction factors as per IS code are used for this purpose. This value may not be the same as the core strength.
- We report results as per IS code. IS code does not take into account the core cutting effect. When accounted for, the results can be higher than those reported. Discussion on this can be taken up with consultants as a separate assignment.
- Visual observations of the aggregate, failure pattern and probable causes of failure and suitable remedies can be discussed separately and are not a part of the scope of conducting the test and reporting results.

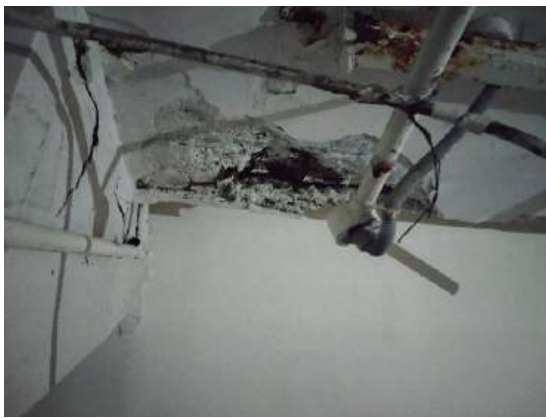
(c) Spalled concrete with R/f exposure and loose cover in beam at next to store room(9) and light control

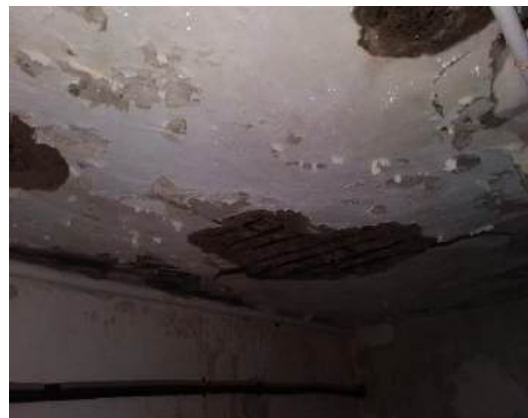
(h) Spalled concrete with exposed R/F in room (9)

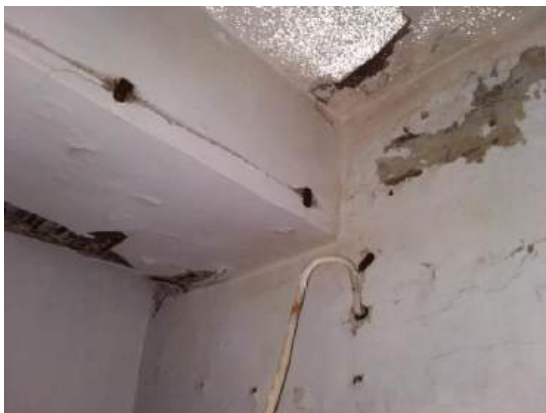
(g) Delamination in beam located in room(9)

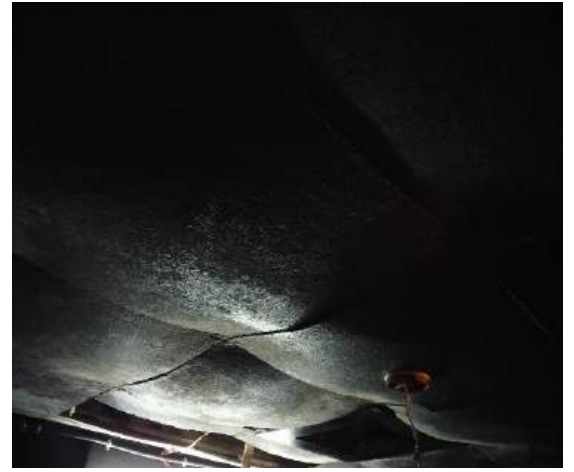
(h) Spalled concrete with exposed R/F in room(9)

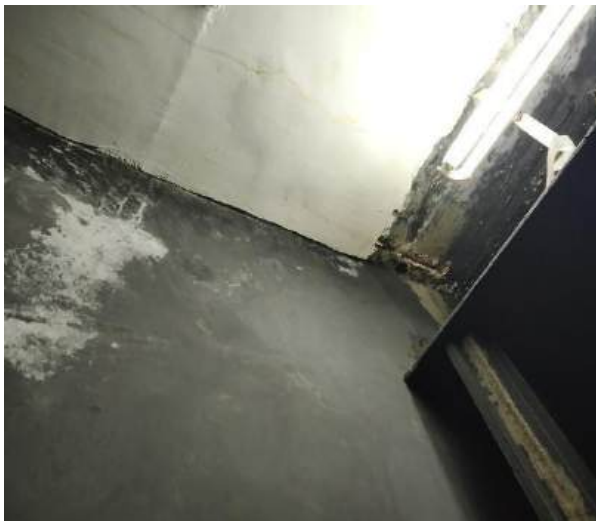
(a) Spalled concrete with R/f exposed in slab at the entrance of black box

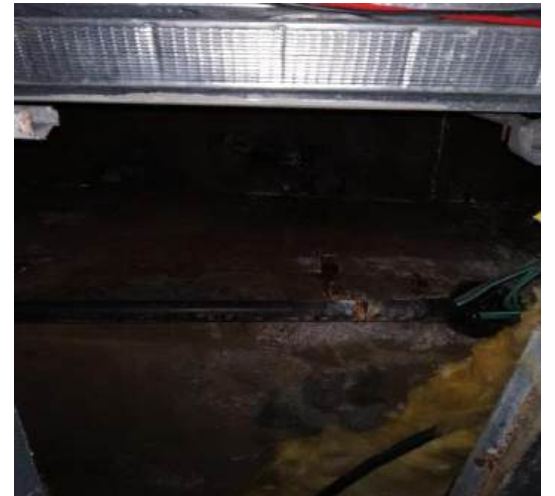
(j) Presence of moisture, blisters and leakage on beam in recording room(17)

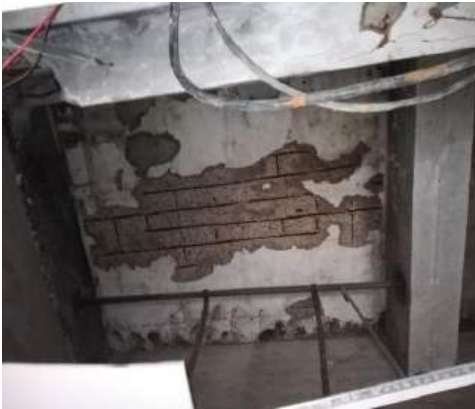
(a) Spalled concrete with exposed R/f in slab at ladies toilet of Dariya Sangam

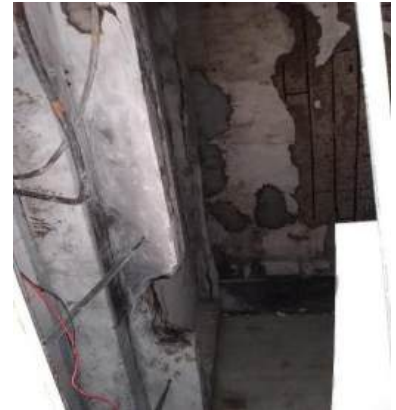
(b) Presence of loose cover & a part of concrete is missing.

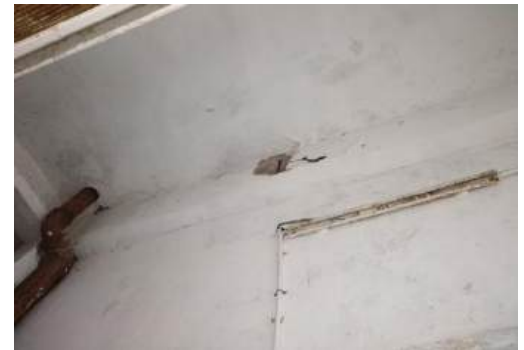
(d) Spalled concrete with R/f exposed along the side of beam of generator room(81)

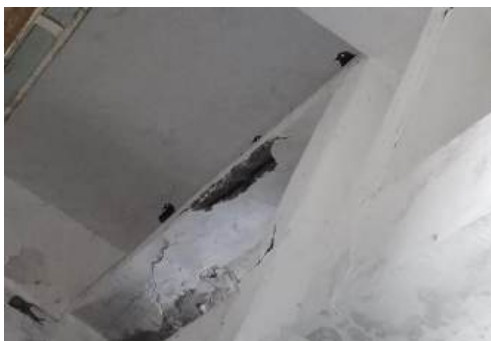
(c) Spalled concrete with R/f exposed in the ventilation projection of Generator room(81)

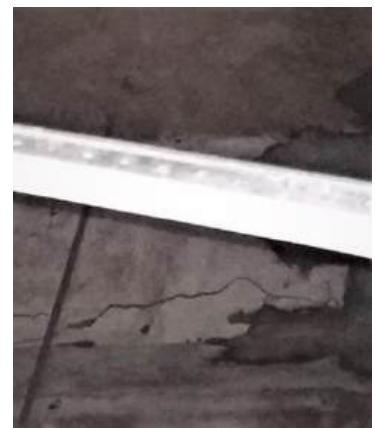
(e) Longitudinal crackin

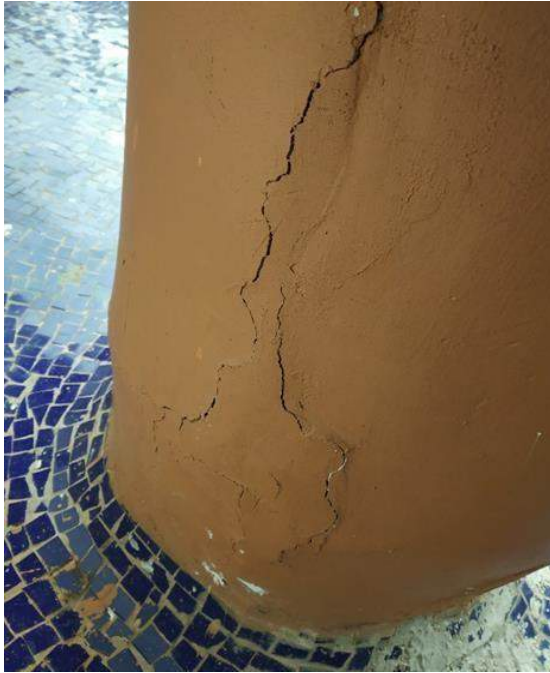
(c) Drainage pipe provided in the circular column is sealed with filling material at 1st floor level.
