Shoreline Analysis Report: Integrated River Basin
and Shoreline Management Plan for Goa

National Institute of Ocean Technology
Ministry of Earth Sciences, Government of India

Integrated River Basin and Shoreline Management Plan for Goa state

Water Resources Department
Government of Goa

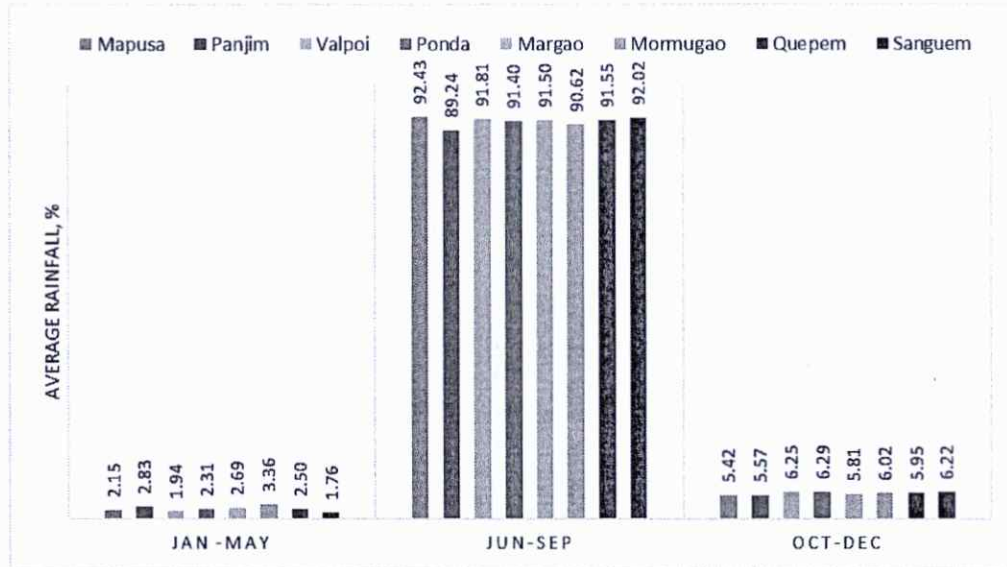
Figure 4-3: Average rainfall (%) along Mandovi and Zuari catchment, 1970-2019

peak annual rain fall of 5114 at Valpoi during 2011 in Mandovi basin and 3276 with a peak annual rain fall of 4969 at Sanguem during 2019 in Zuari basin. Along the Zuari basin the stations Mormugao, Margao, Ponda, Quepem and Sanguem are along the river from sea side, the annual average rainfall is 2070, 2510, 3320, 3445 and 3672 mm respectively. Similarly, along the Mandovi basin Panjim, Mapusa and Valpoi are along the river from sea side, the annual average rainfall is 2887, 2956 and 4059 respectively. It can be observed in both the cases that rainfall intensity is less along the coast and increase towards the landside. It is also observed that monsoon rainfall is in the order of 90 % during June to September, 7 % during post-monsoon period of October to December and 3 during pre-monsoon from January to May months.

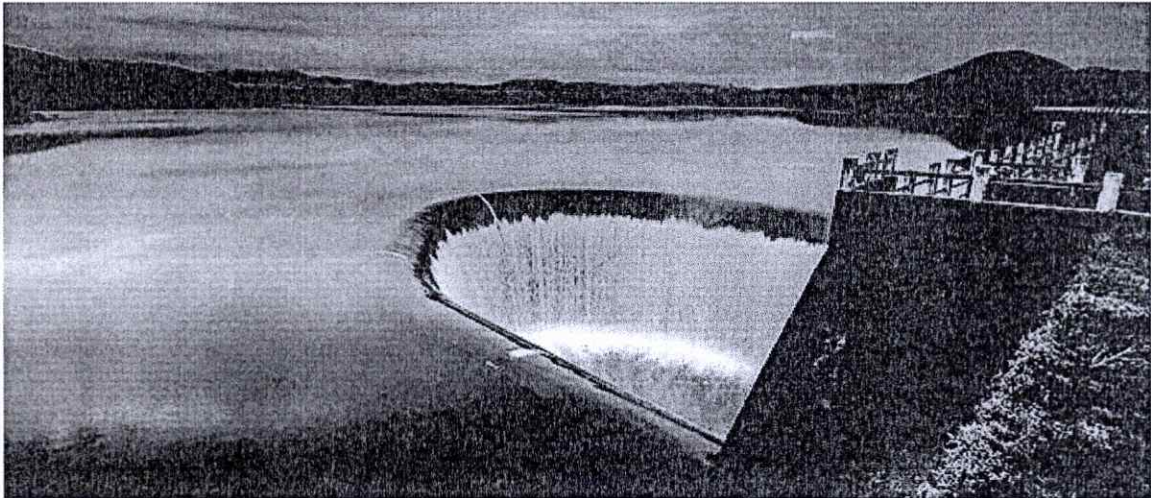
Figure 4-13: Salaulm Dam on Sanguem River (Zuari Tributary)

The Salauilm dam is the major irrigation project that is constructed across Salauilm/Sanguem River, which is a major tributary of Zuari River in the year 2000. The length of dam is about 1000m and it is an integral component of the Salauilm Irrigation Project which envisages benefits of irrigation and drinking water supply. The dam is a composite earth-cum-masonry dam of 42.7 meters height with a water spread area of 24 km^2 . The river drains a catchment area of 227 km^2 with a gross storage capacity of 234.36M cu.m. This project has led to submergence of 2964 Ha land, which includes cultivated area of 1240 Ha, forest of 706 Ha and uncultivated Govt. land of 1018 Ha.

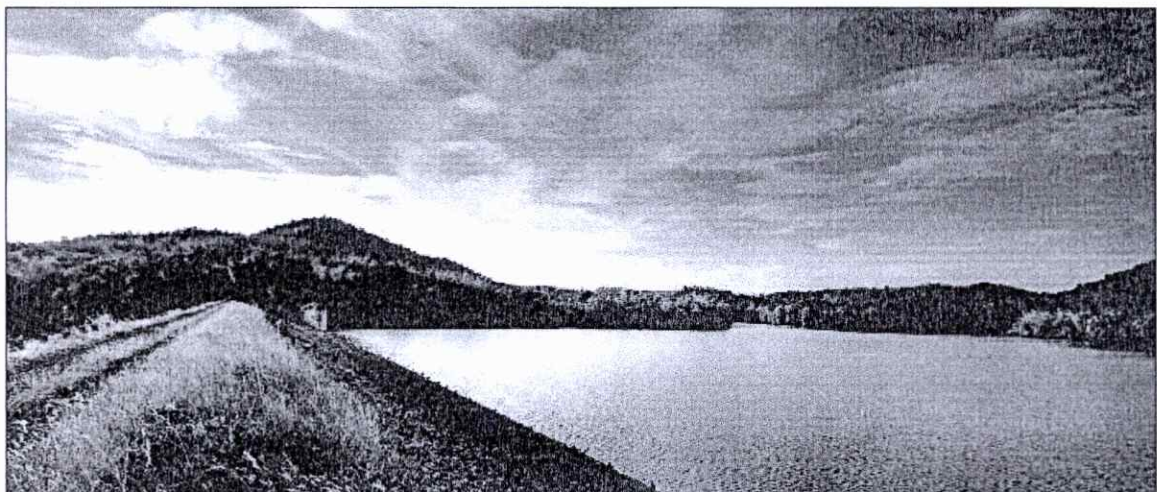
Figure 4-14: Moisal Dam on Panchawadi Minor Irrigation Project

The Moisal dam is part of Panchawadi minor irrigation project that drains water into Zuari River. The length of dam is about 230m and it is constructed in 1986 which envisages benefits of irrigation and drinking water supply. The dam is an earth dam of 20 meters height with a submergence area of 53 ha and gross storage capacity of 44709 h.m.

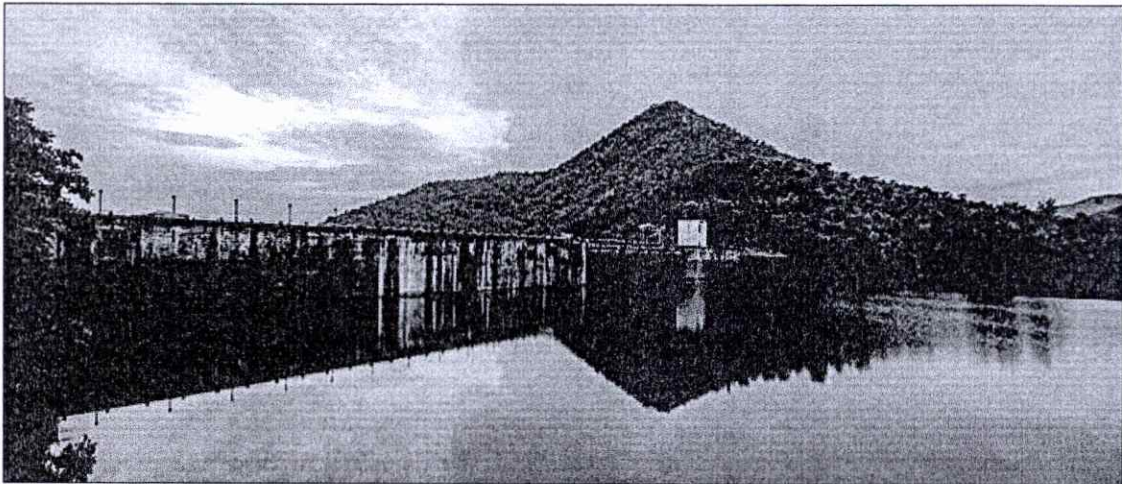
Figure 4-16: Anjunem Irrigation Project

The Anjunem irrigation project is located on Costi river at Anjunem village in Sattari Taluka of North Goa District, a tributary of Valvanti River under Mandovi Basin (tributary of Mandovi River). The project envisages construction of Gravity Masonry Dam of 176m long and 42.6 m height in 1989. This Project is a medium irrigation project completed in 1989 and the full ultimate potential of 4600 Ha (2100 Ha CCA) has already been created of which 1415 Ha (CCA) is underutilization.

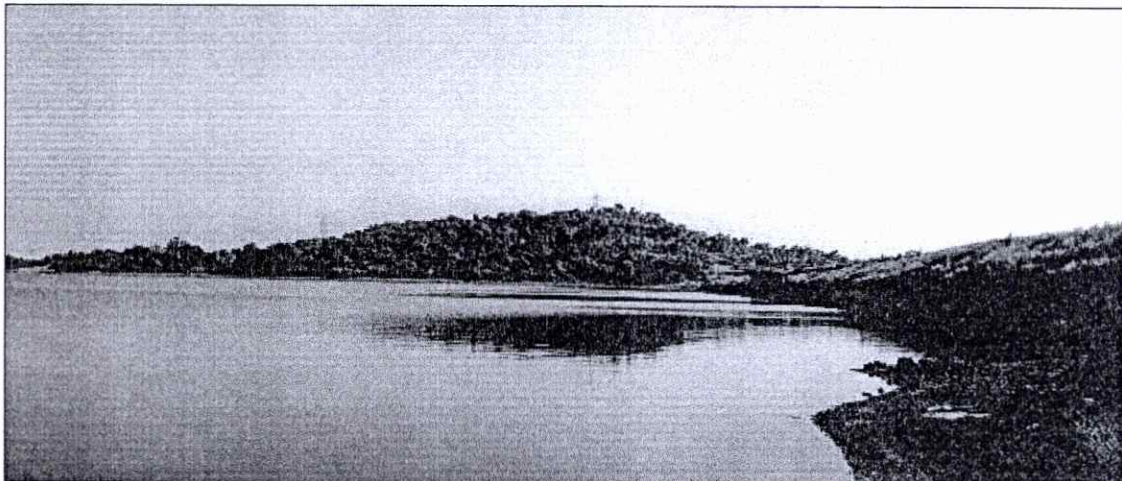
Figure 4-17: Amthane Minor Irrigation Project

The Amthane dam is part of Amthane minor irrigation project that drains water in to Mandovi River. It is an earth-fill dam constructed in 1988 with a length of 450m and height of 29.4m. This project has a total capacity of 597 ha.m.

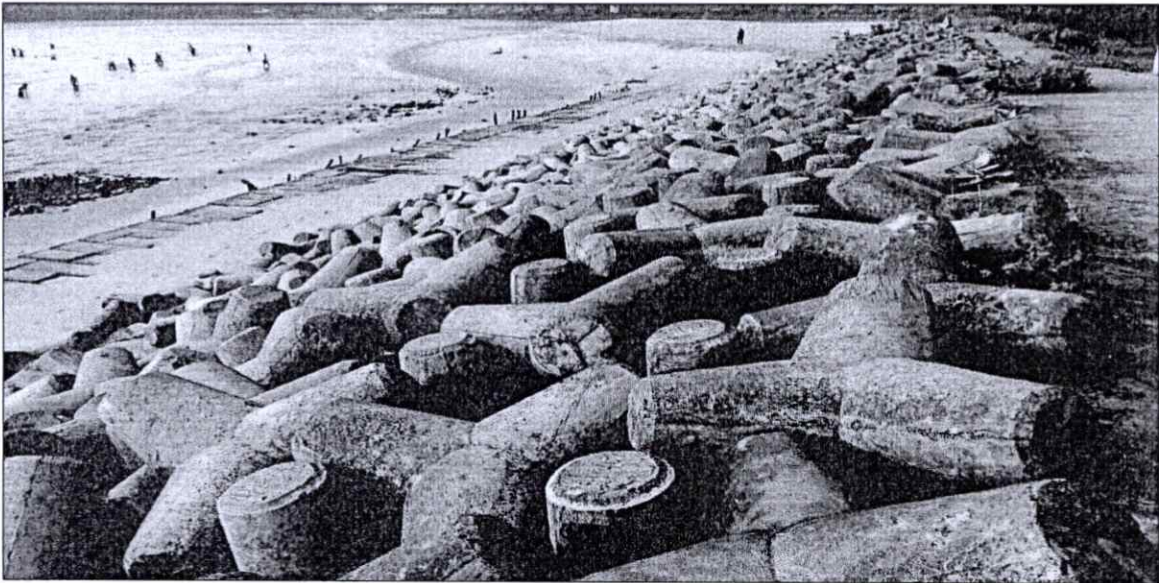
Figure 5-1: Shore protection measures at Keri/Tiracol

Tiracol beach experiences seasonal erosion and accretion. A seawall was constructed using the Tetrapods to protect the shoreline. It is observed that the Tetrapods were dislocated and settled down at few locations. The sea wall has been partially destroyed due to the wave action. Steep cut beach berm and uprooting of Casuarina plantation is observed here. Cliff erosion is observed at Anjuna. The coastal stretch extending from Harmal, Mandrem, up to Morjim shows accretion to stable trend. Chapora, Vagator in the north show eroding to stable nature. Other regions showing stable nature of coast are south of Anjuna, Candolim, Sinkerim between Calangute and Nerul and Shinken. Few pockets of erosion are observed north of the Chapora River around Arpora, south of Calangute.

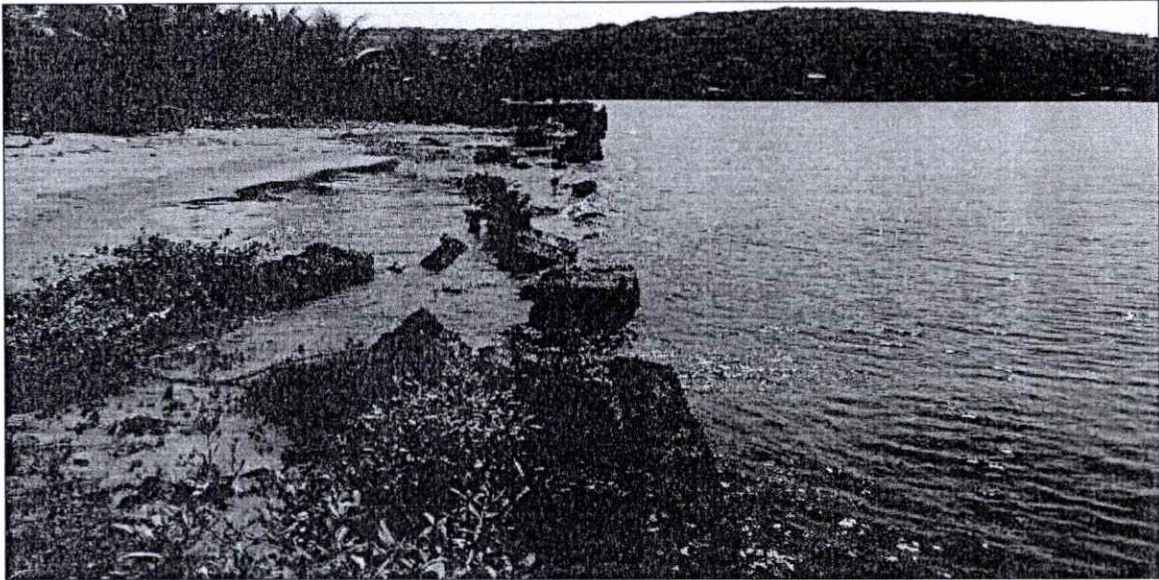
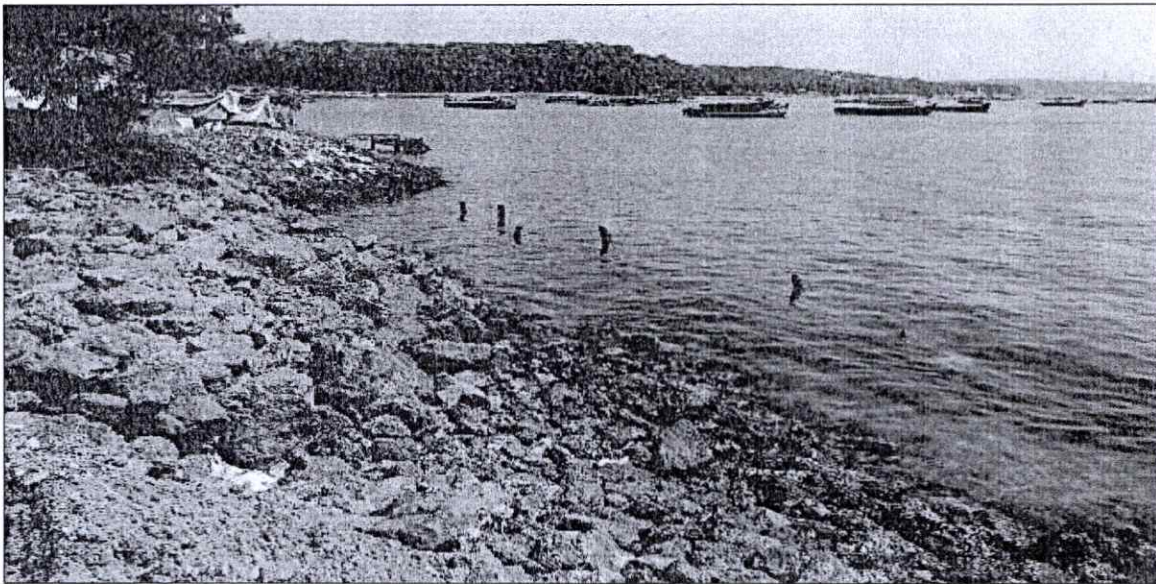
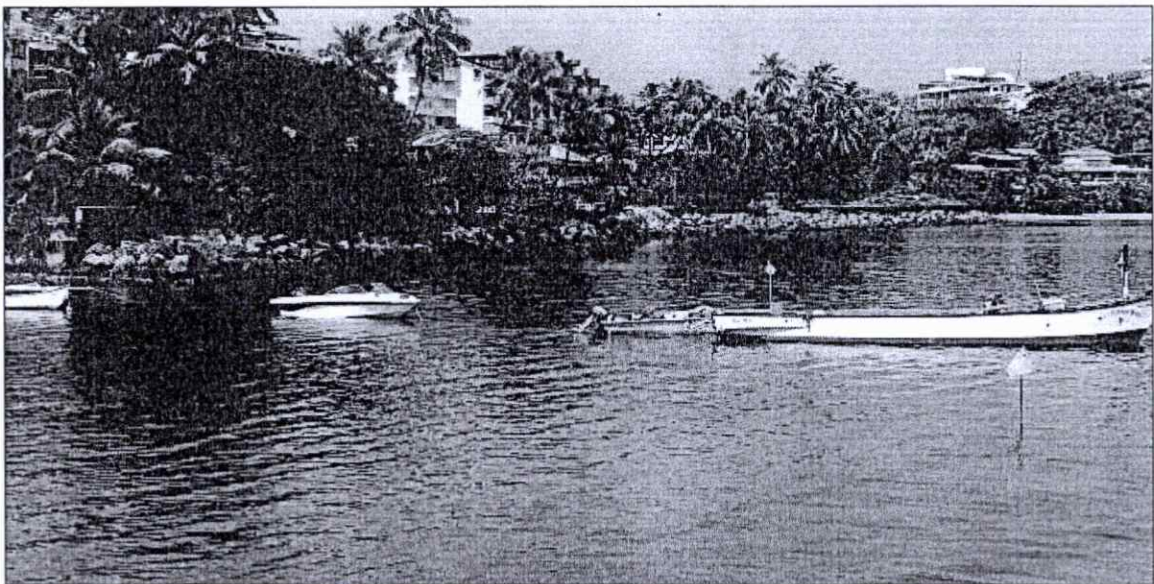
The Central coastal segment of Goa comprises of regions around the Aguada and Mormugao Bay. The Mandovi and Zuari rivers discharge into these respectively. This coastal stretch is majorly stable in nature, except few small segments of erosion. Coco beach, north of Nerul river mouth a pocket beach showing local erosion. Eroding segment is also observed near Dona Paula and Vaddem beach. The famous Miramar beach is located in this segment near Caranzalem. Sea walls have been constructed at several locations around Miramar, Dona Paula, Cabo Hill, Campal to protect the coast and remedial measures have been taken for stabilizing unstable slopes of Cabo Hill.

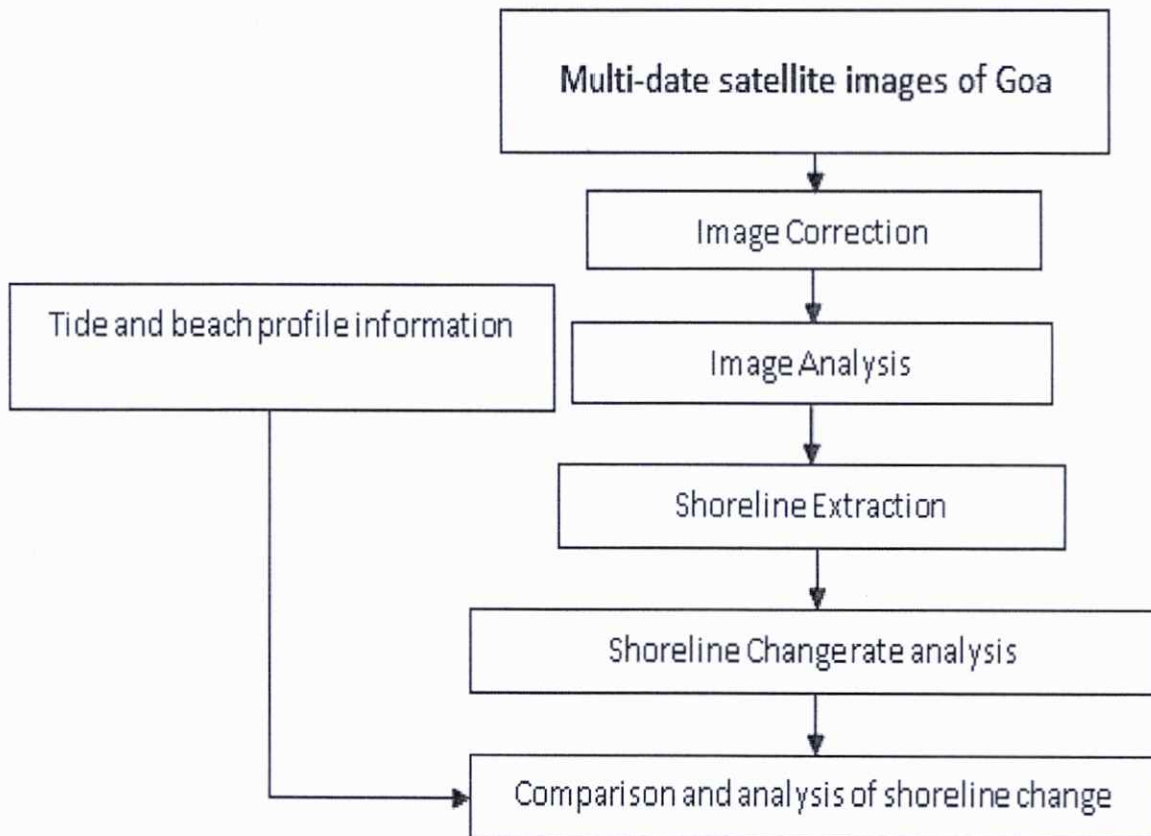
Figure 6-1: Flow chart of Shoreline Analysis

The shoreline change analysis has been carried out using open-source data as well as National Remote Sensing Agency (NRSA) to estimate the rate of change in terms of distance eroded or accreted. The shoreline change rate from 1972 to 2020 has been analyzed using Digital shoreline change analysis system (DSAS) that works within the Geographic Information System (ArcGIS) software. DSAS computes rate-of-change statistics for a time series of shoreline vector data. The approach of shoreline change analysis using satellite imageries is shown in Figure 6-1.

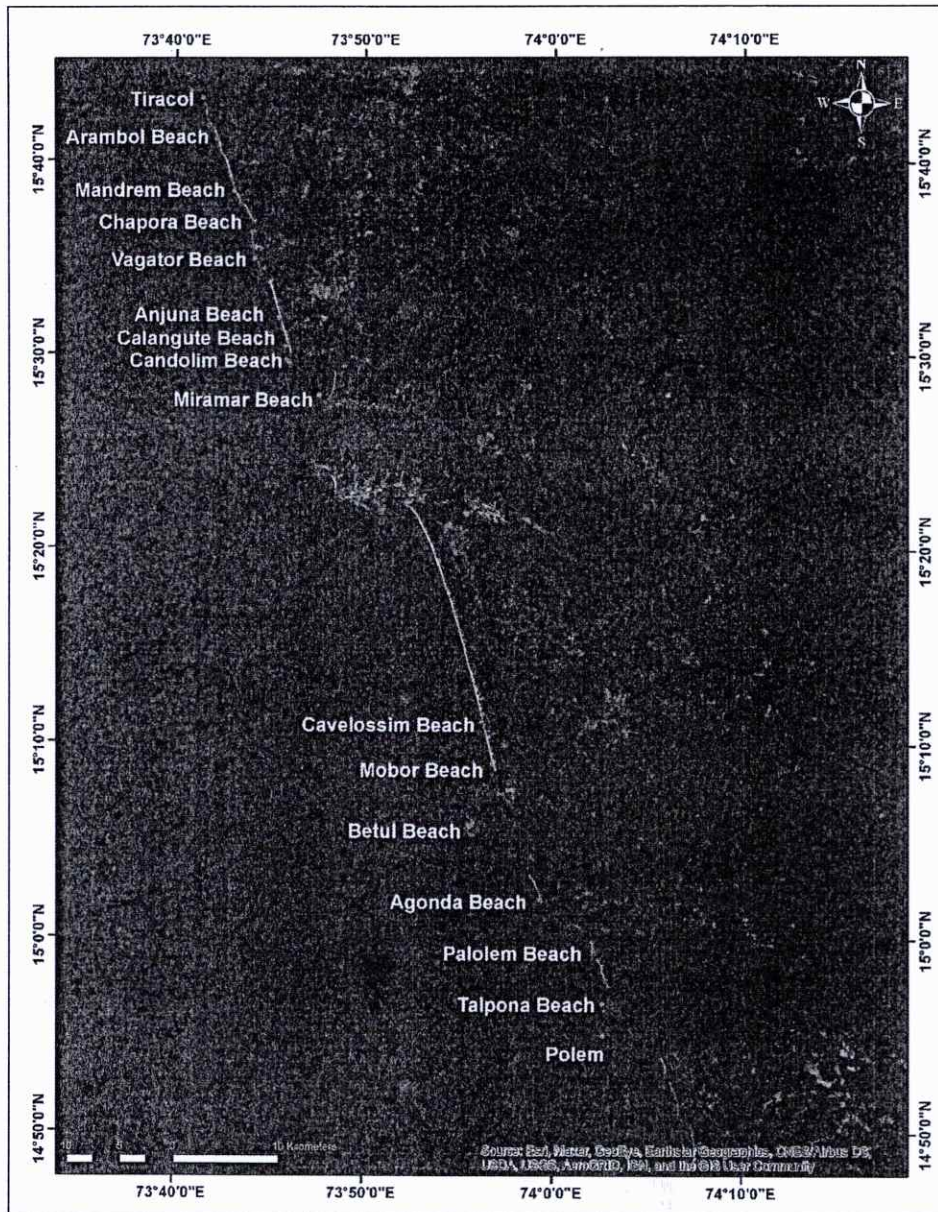
Figure 6-41: Location of Erosion hot spots where trend analysis is carried out

The shoreline trend analysis for the erosion locations along the Goa coast; Tiracol, Chapora, Vagator, Anjuna, Calangute, Candolim, Miramar, Cavelossim, Betul, Agonda, Palolem, Talpona and Polem are shown in Figure 6-42 to Figure 6-46. The trend analysis of the shoreline position from the baseline has been indicated for the period from 1972 to 2020 along with decadal trends for the period 1972-1980, 1981-1990, 1991-2000, 2001-2010 and 2011-2020.

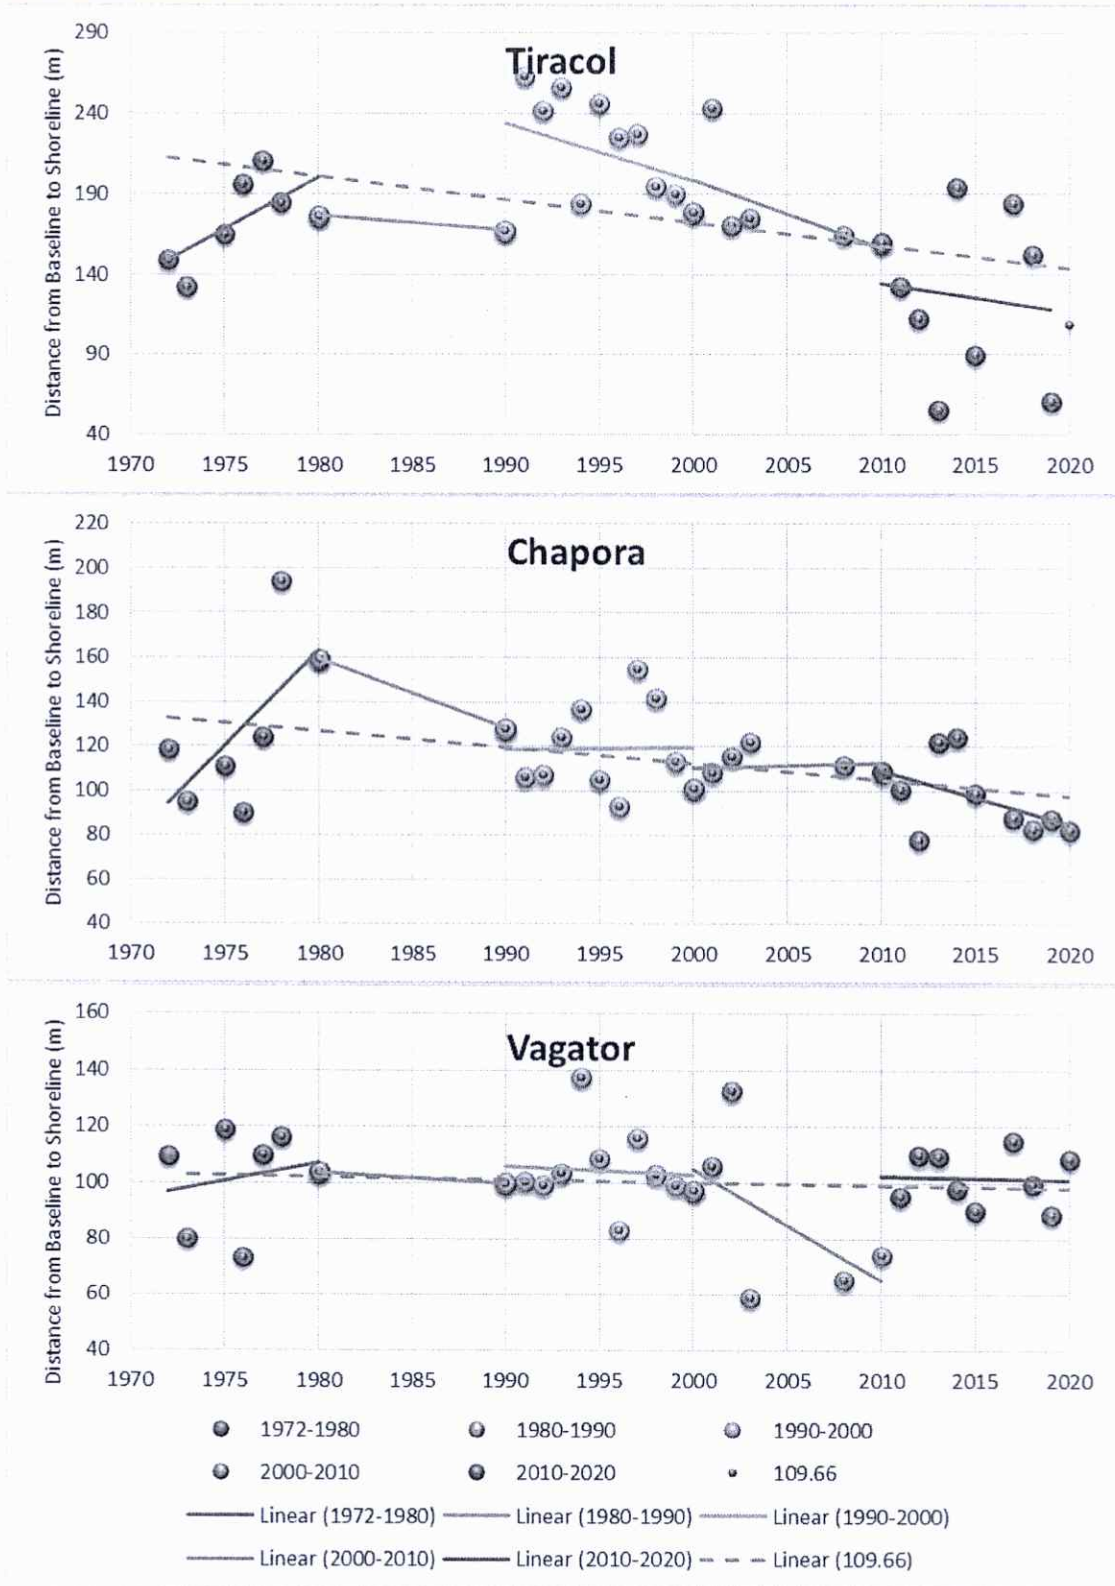
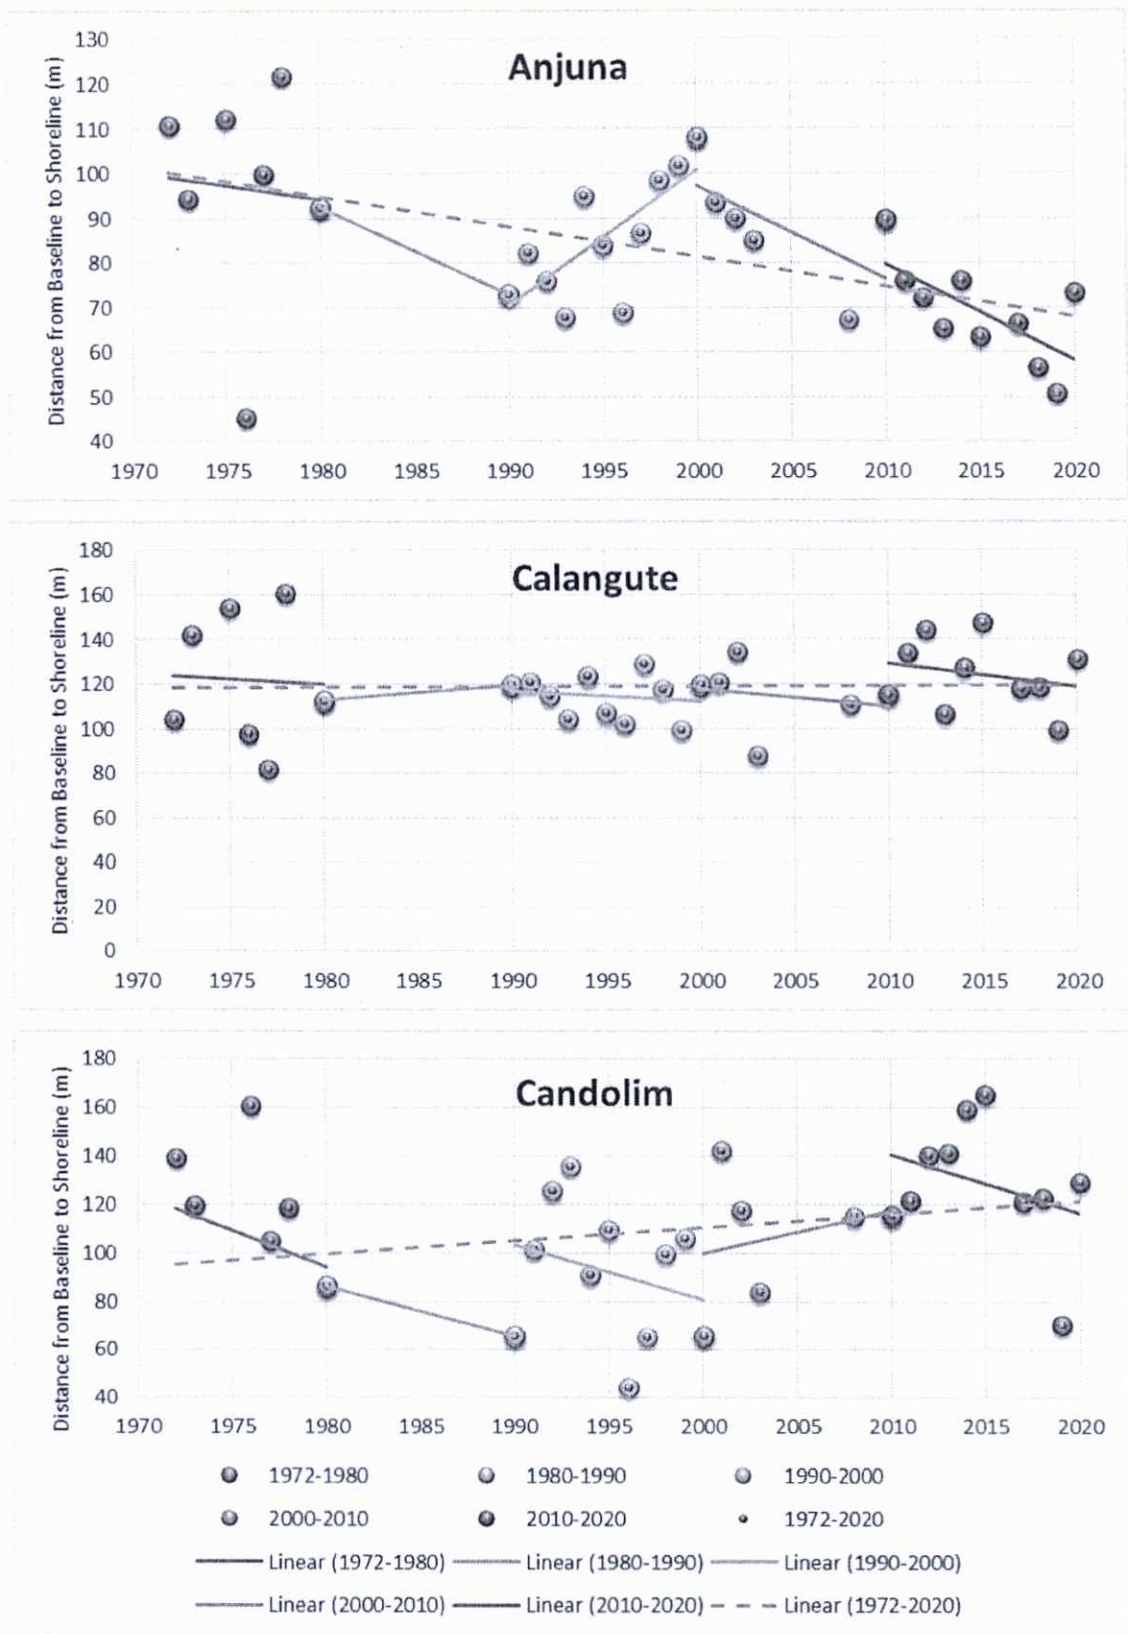
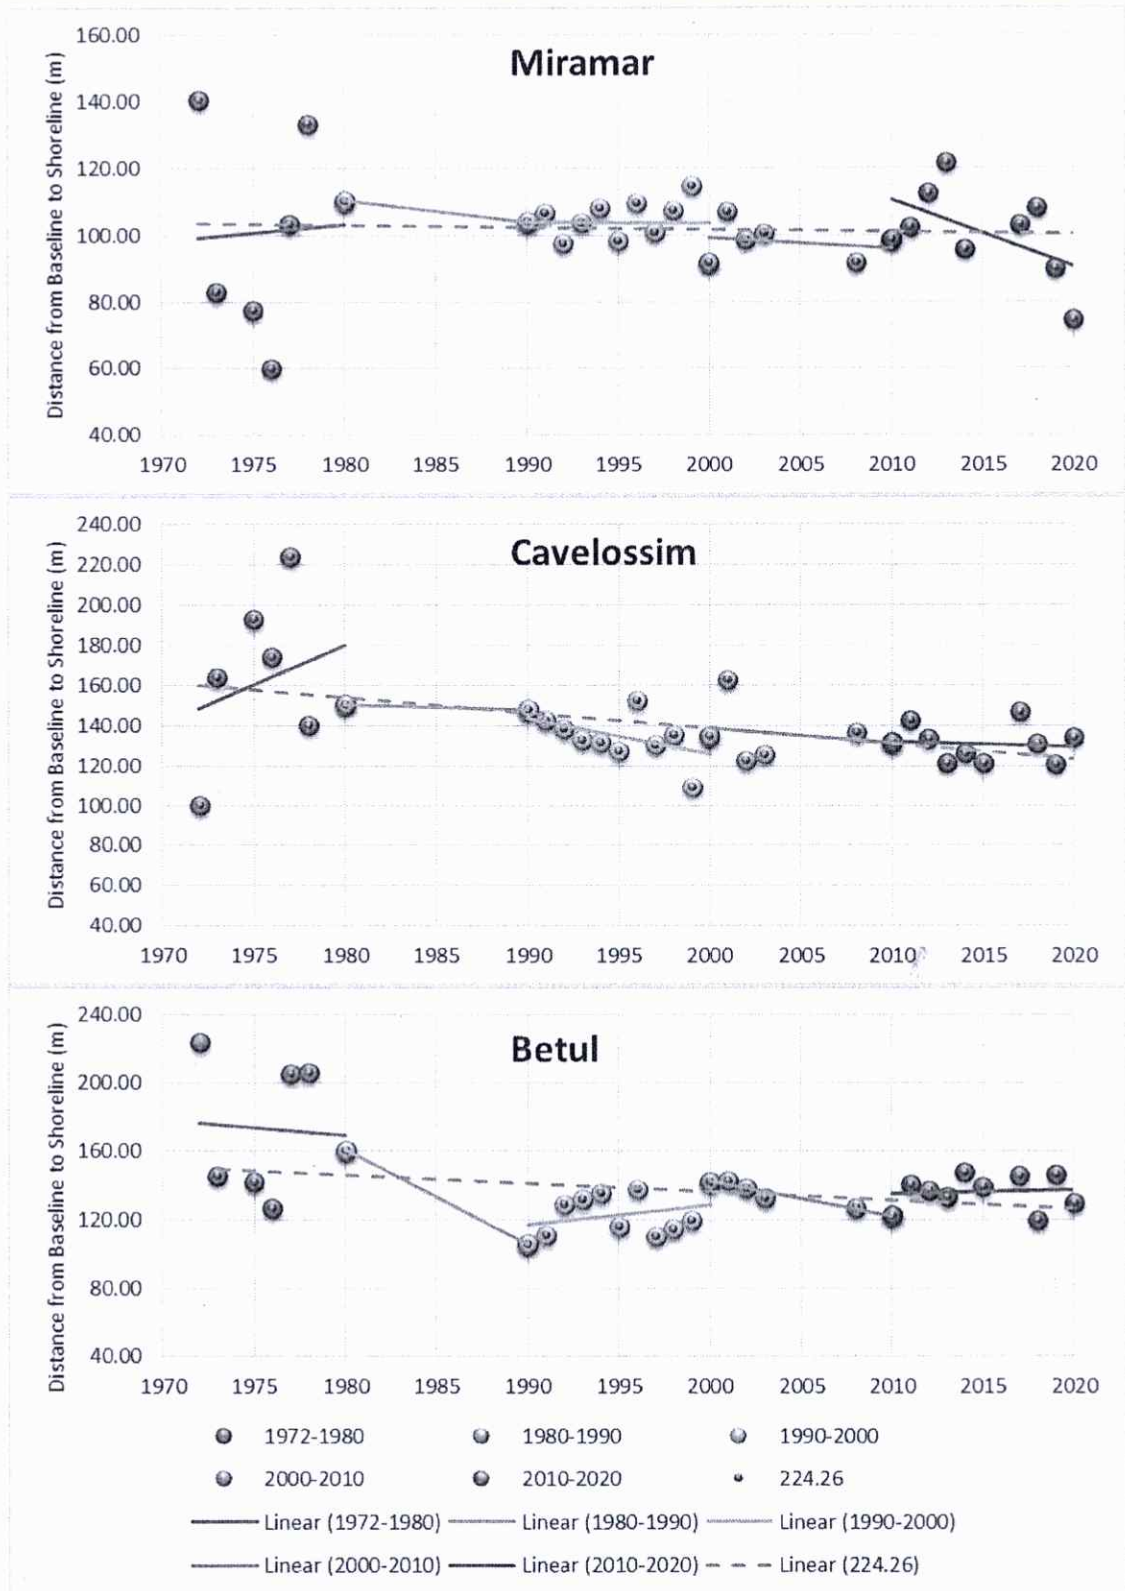
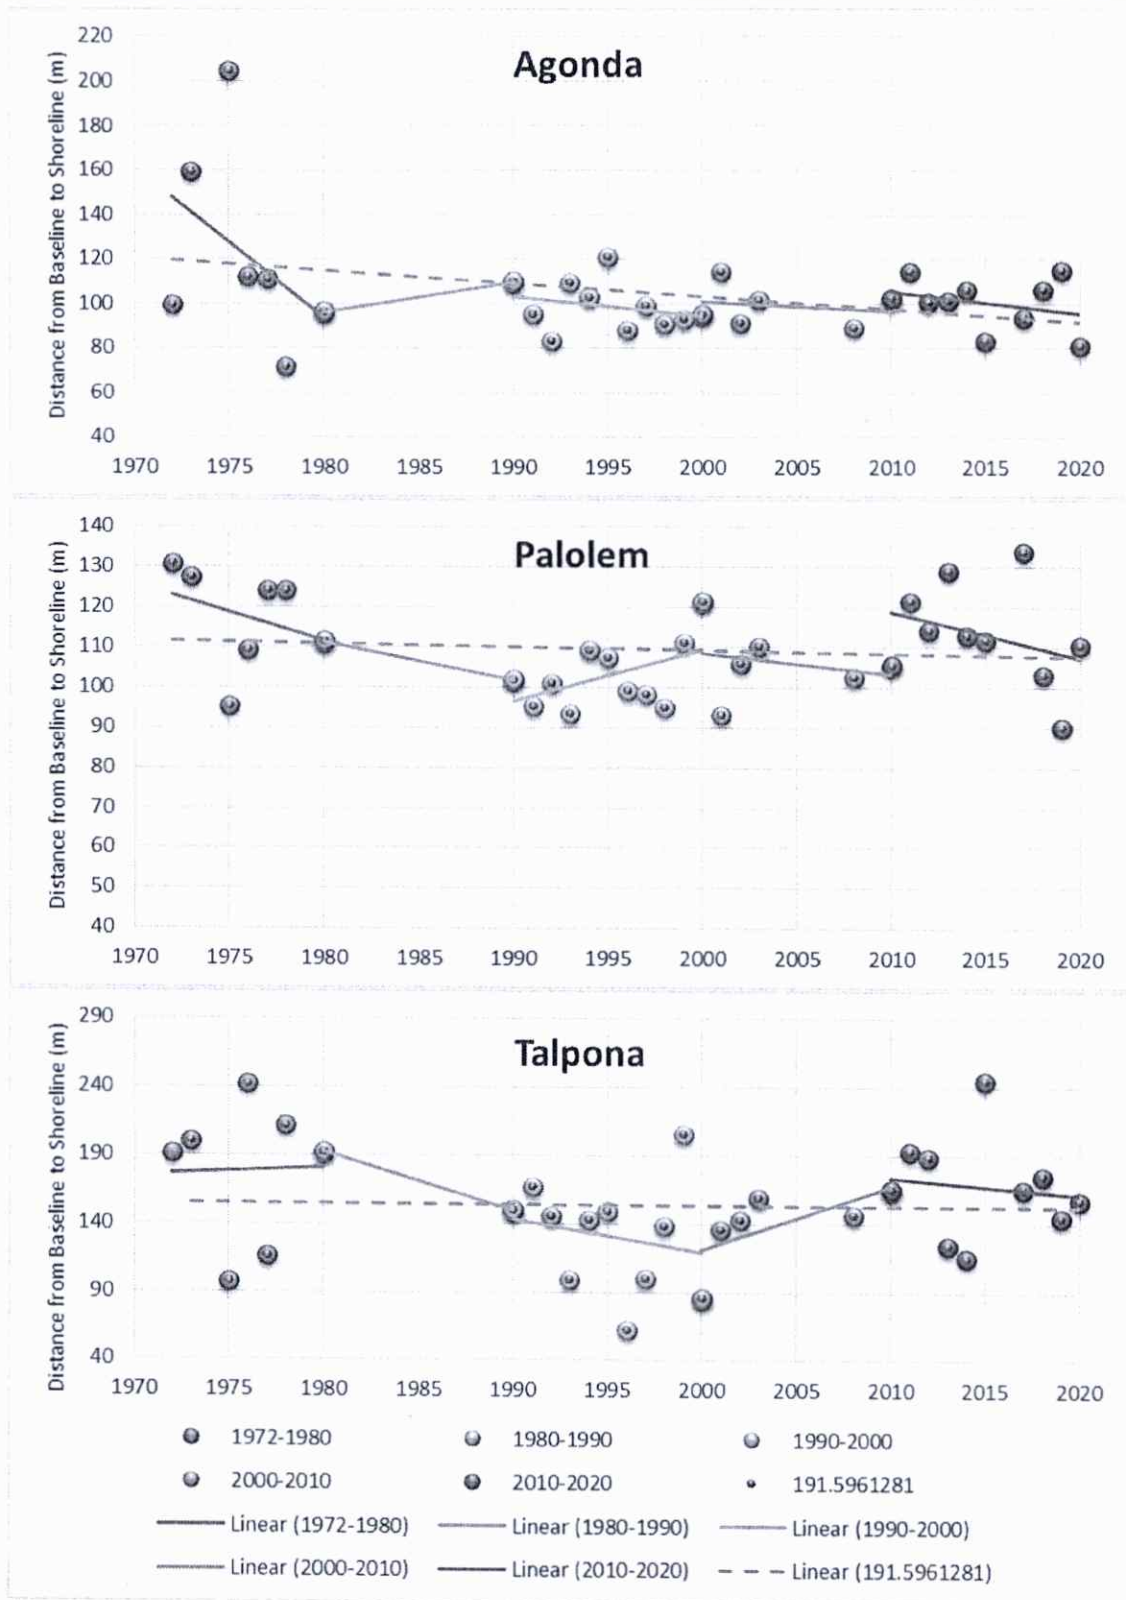
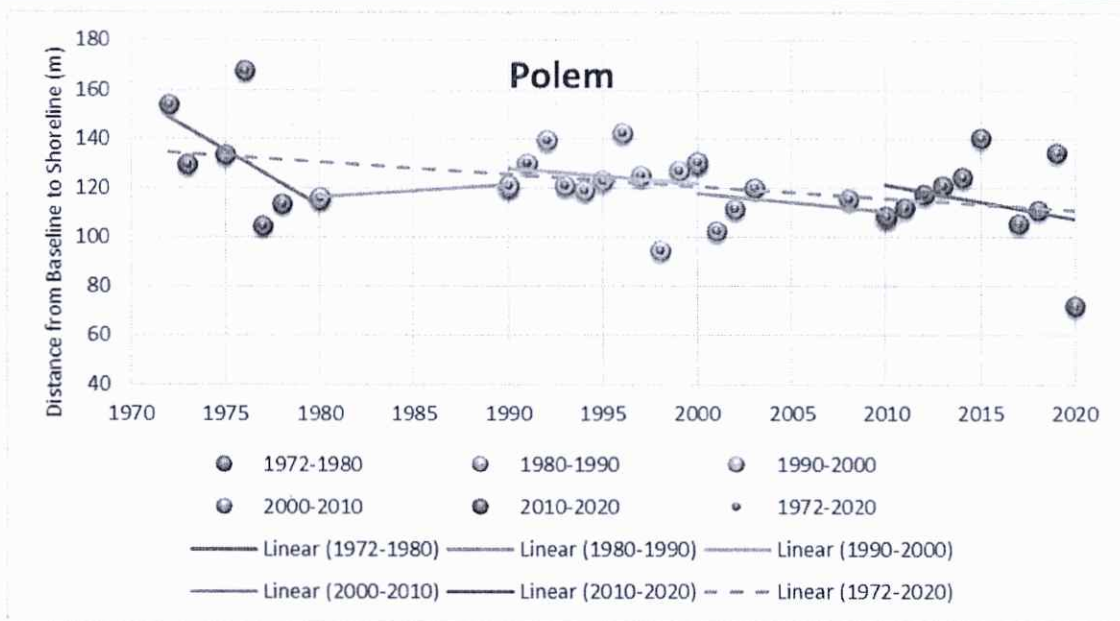
The shoreline position to the baseline is high when compared to previous year indicates accretion while the shoreline position to the baseline is low indicates the erosion. From the trend analysis of the erosion and accretion hotspots, it can be noted that the period from 1990-2001 has been showing the accreting trend in both erosion and accretion hotspots. With the high resolution satellite images of 5m from 2010 to 2020, the shoreline position has been precisely digitized and the erosion spots indicates eroding trend and the accretion spots indicate accreting trend except Arambol.

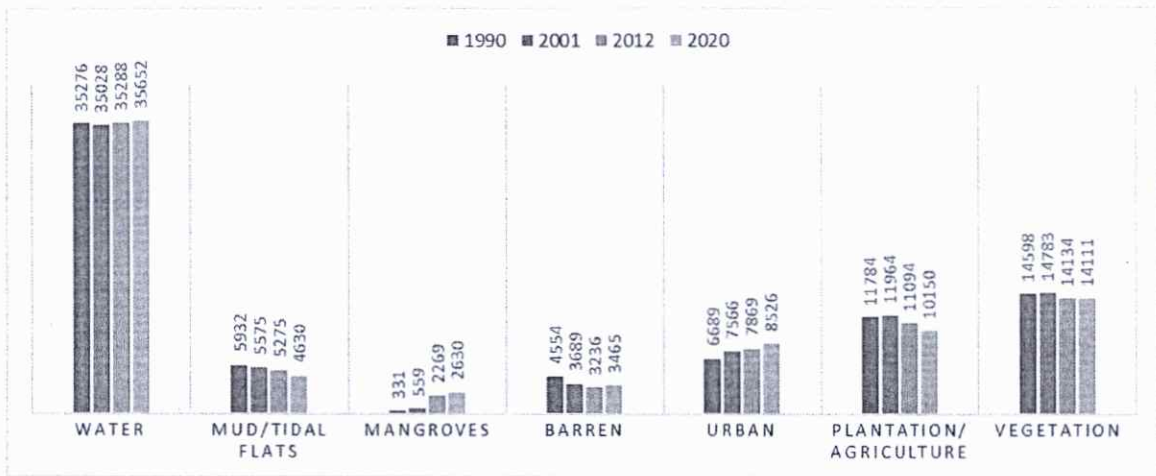
Figure 7-3: Area of LU/LC classes in hectare 1990 to 2020

From the results, it is observed that the urban and mangrove area have been increased and a bar chart representing the land use/land cover area is shown in Figure 7-3 and Figure 7-4.

The land use/ land cover changes for the years 1990, 2001, 2012 and 2020 has been analyzed. From the catchment characterization, it is observed that, the urban and mangrove area have been increased since 1990.
